Material Condition and Usage Monitoring Sensors and Algorithms for Adaptive Management of Legacy and New Platforms

Neil Goldfine, Don Damm

JENTEK Sensors, 110-1 Clematis Avenue, Waltham, MA 02453

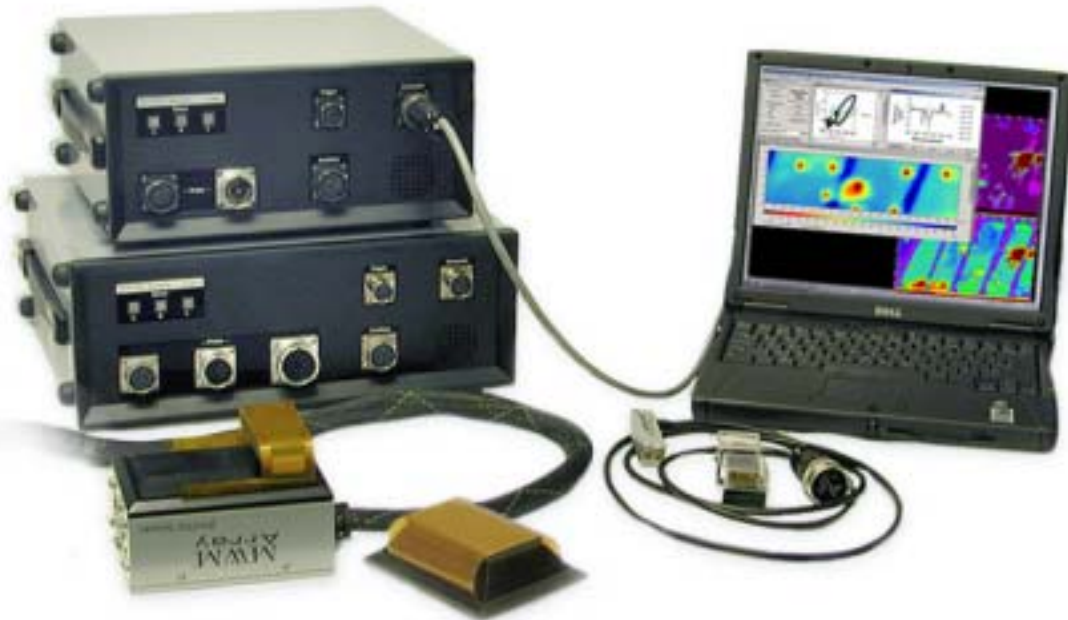
37 Channel
MWM-Array
Probe

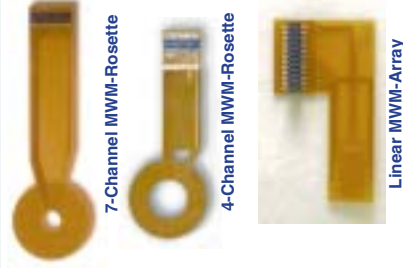
7-Channel MWM-Rosette

4-Channel MWM-Rosette

Linear MWM-Array

Surface Mounted MWM-Array Configurations

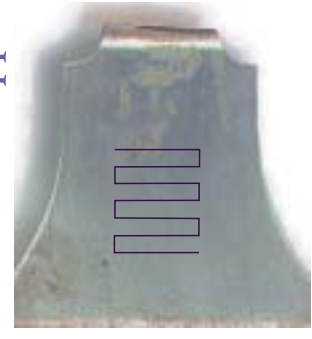
MWM-Array generated normalized permeability images for a double-notched, low-alloy 4340 steel tensile specimen loaded to failure. Images illustrate the ability to obtain distribution of residual stresses due to correlation between permeability and stresses.

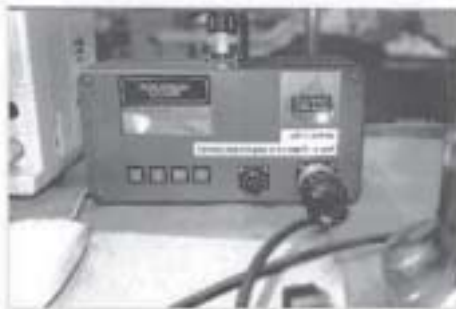
Remote Instrument Module

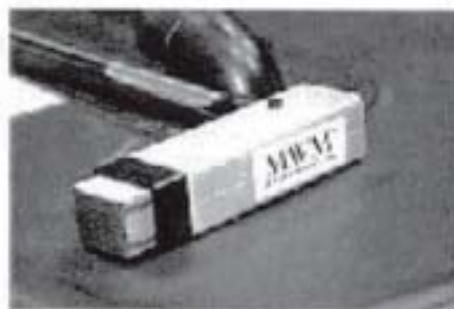
MWM Probe

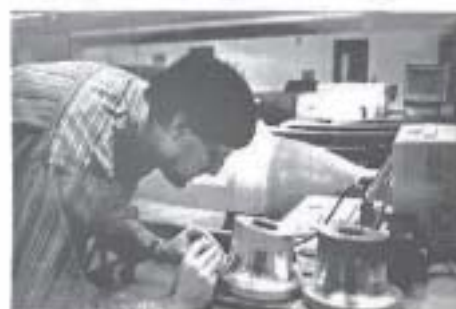
Propeller Inspection Region
